Paihia WWTP, Innovative in Pond Removal of Ammonia Using Bioshells®

Abstract

Situated in the Waitangi Forest in the Bay of Islands, Paihia WWTP has a discharge that feeds into the sensitive Waitangi wetlands, home to the Northland Mudfish. To improve this habitat, it has been necessary to upgrade the plant that serves Paihia, Opua, Waitangi and Haruru to meet a 2 mg/l ammonia consent. Like many wastewater systems in New Zealand, Paihia WWTP is a pond based system built in the 1980s. not intended to meet nitrogen removal requirements.

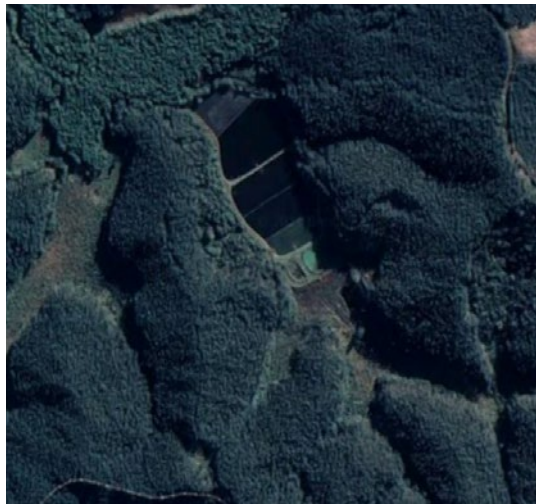
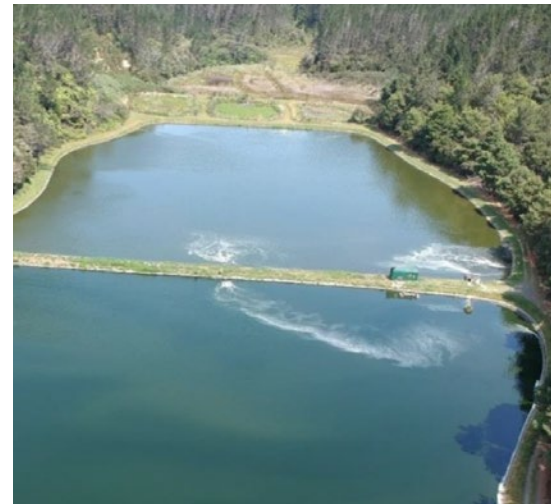
Figure 1: Aerial Views of Paihia WWTP showing surrounding Forest and Wetlands to existing Ponds (Images from Google Earth, Marshall Projects Ltd)

Paihia Wastewater Treatment Plant (WWTP) in the Bay of Islands serves approximately 5000 residents in the communities of Paihia, Waitangi, Opuia and Haruru. In summer, the population in the area can exceed over 11,000 FTEs. The WWTP was originally built in the 1980s in a remote location in the Waitangi Forest and has seen considerable growth in the catchment. The site is bounded by natural wetlands and forestry, with 2 drainage streams running the length of the site, Limiting the footprint of the site available for expansion. The discharge from the site is to a wetland area, part of the Waitangi Wetland system.

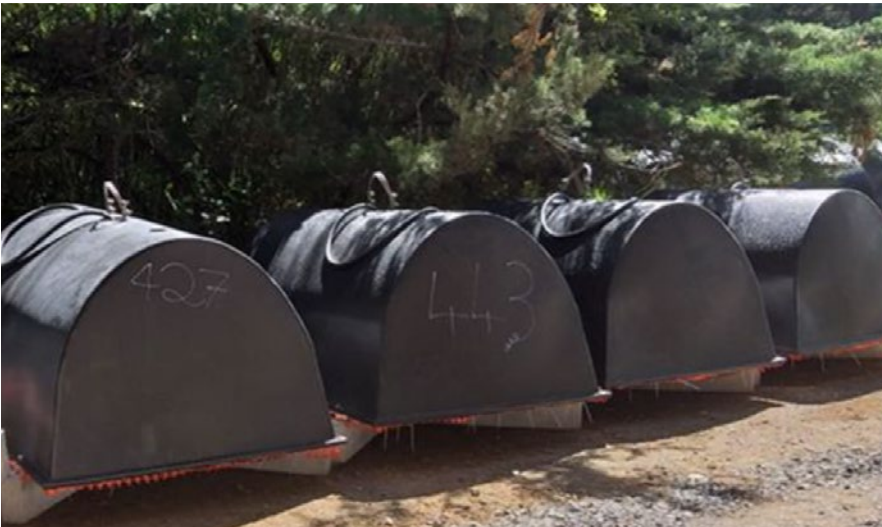
Figure 4:

Bioshells® prior to Installation (from Marshall Products Ltd).

A series of plastic shells retain random plastic media. By providing an air supply to the base of the units, there is enough oxygen to enable a population of nitrifying bacteria to establish on the surfaces. A retaining mesh on the bottom is necessary to hold the media in place, and the whole assembly is fixed to a concrete subframe. This prevents buoyancy. To each assembly a stainless-steel lifting cable is provided for installation, or removal for maintenance. Each Bioshell® unit is supplied with a dedicated air hose from a common air manifold.

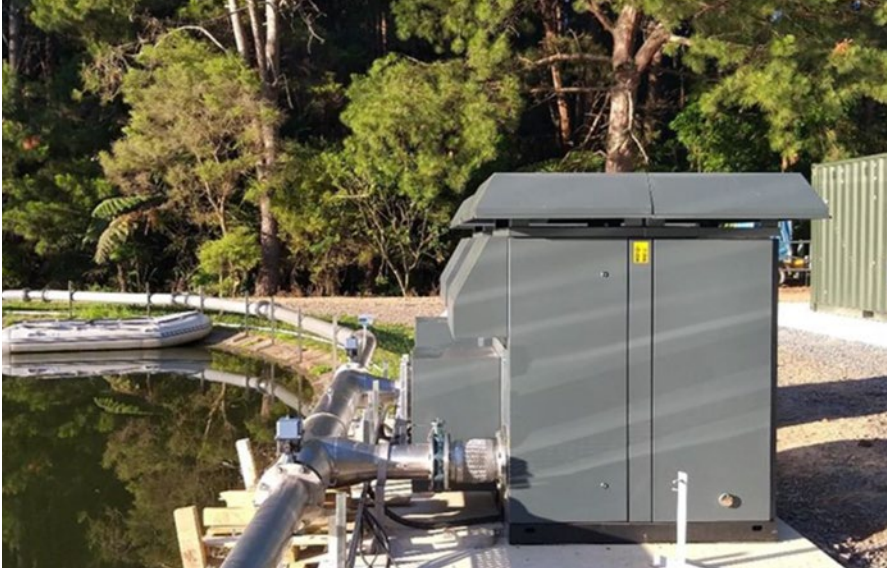
Figure 5:
“Land Based” Installation of Blowers, Air Manifold and Generator/Control Room
(from Marshall Projects Ltd)

At Paihia to meet the Peak summer loading condition of 120 kg NH₃-N/d, 553 Bioshells® have been installed, with air supplied by duty standby Roots Z Series screw blowers. Photographs of the project installation are shown to the left.

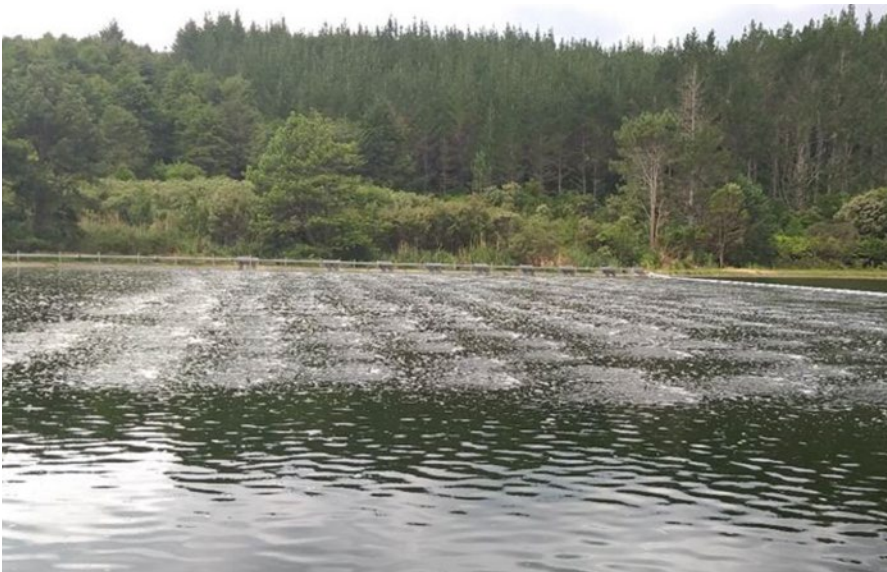
Figure 6:
Bioshells® Zone showing location of Bioshells® by air pattern prior to cover installation
(from Marshall Projects Ltd)

WCS advised that algal competition could occur on the media, so a floating cover system was installed. This was the first use of Hexacovers in NZ, which provide an interlocking flexible cover across the Bioshells® zone.

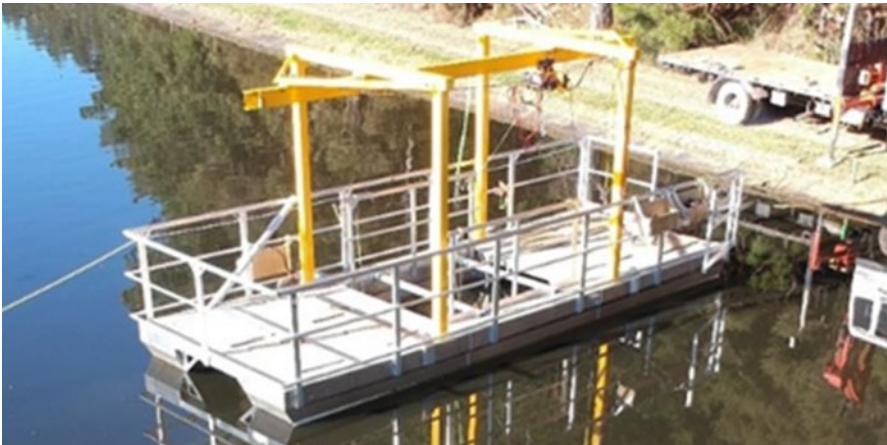
Figure 7:

“Land Based” Installation of Blowers, Air Manifold and Generator/Control Room
(from Marshall Projects Ltd)

Prior to this project a small number of Bioshells® had been installed in South Island on small ponds for enhanced BOD removal. As the pond was small a crane had been used for installation. However, for Paihia, with nearly 0.4ha of pond area for the installation, and limited access, a 110m crane reach would have been required. Marshall Projects innovated by designing and using a twin hulled barge with permanent lifting frame. By setting up guide wires across the pond, it was then possible to transport Bioshells® across the pond and install in lines.

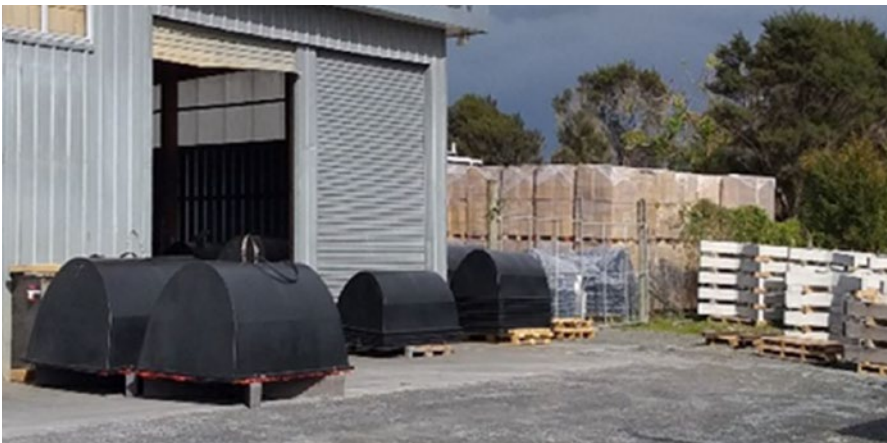
Figure 8:

Local Fabrication Facility
(from Marshall Projects Ltd)

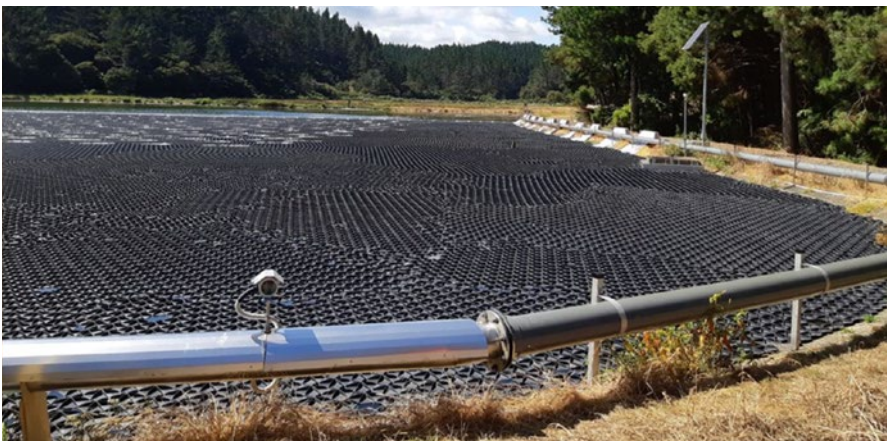
Figure 9:

Complete Installation
(Image from A Springer)

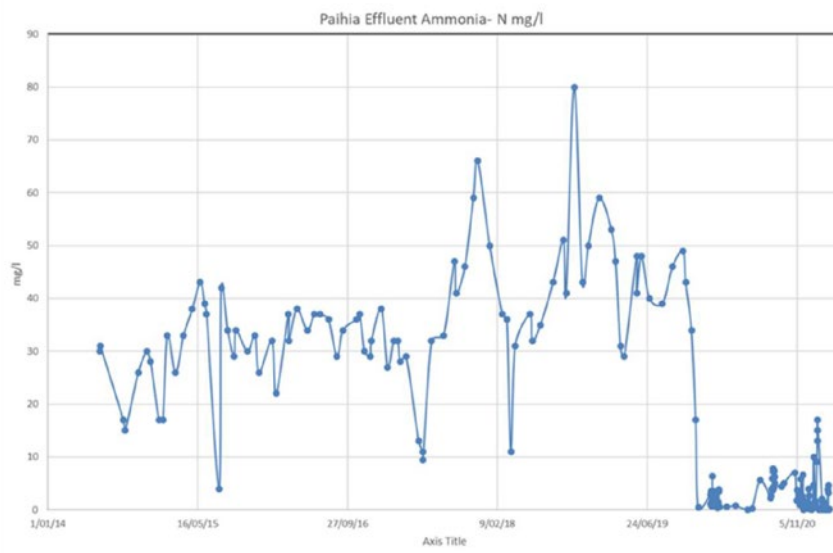
Figure 10:
Effluent ammonia-N
mg/l 2015-2021

Prior to commissioning the effluent ammonia in the Paihia Effluent had a median of 37 mg/l and a total nitrogen of 41.5 mg/l. In 2020 to Feb 2021 this reduced to median 1.9 mg/l NH₃-N and 25 mg/l TN-N a reduction of 95% NH₃-N and 40% TN.

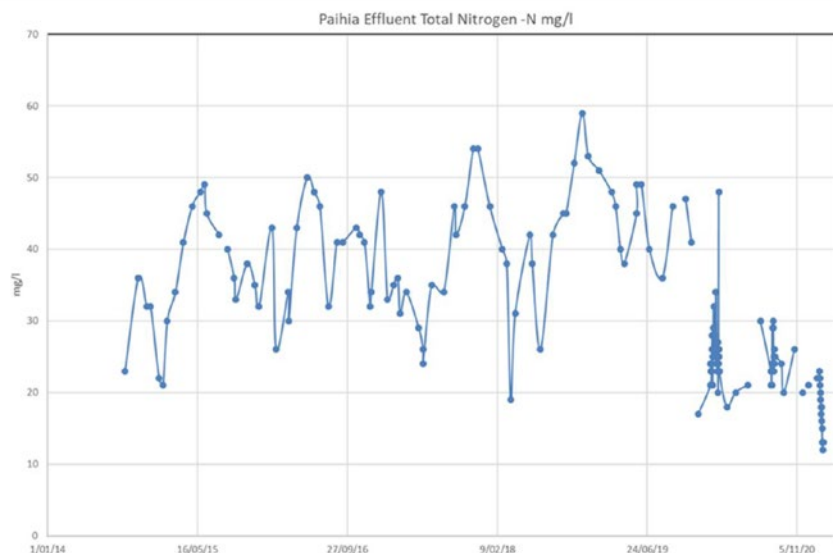
Figure 11:
Effluent Total Nitrogen-N
mg/l 2015-2021

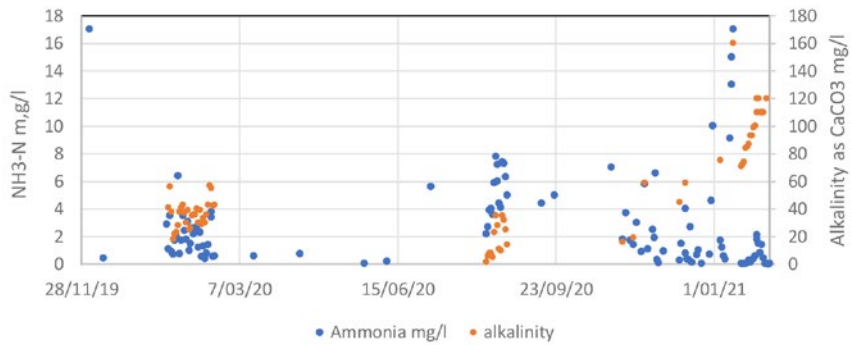
Figure 12:

Effluent ammonia and alkalinity since Bioshell® Commissioning

Figure 12 demonstrates the shortfall in alkalinity in the effluent and the relative performance in the plant.

Relationship between effluent ammonia and affluent alkalinity

The single elevated ammonia result in January 2020 testing is a result of generator down time and subsequent loss of air. Despite this abnormal result the 4 week testing period achieved a median ammonia < 2 mg/l with low alkalinity levels. Performance remained good through the summer and autumn. In July routine monitoring showed an increase in ammonia concentration. A two week survey undertaken to demonstrate winter performance in August continued to show elevated ammonia results, and very low alkalinity results.

Additional chemical alkalinity was added to the pond system by manual dosing of sodium bicarbonate, and so increased the alkalinity and pH commencing in October 2020. As seen in the data, the alkalinity rose slowly in available concentration, but once elevated, significant improvement in ammonia

Despite increased alkalinity in early January 2021, a few elevated ammonia results occurred. At this time a reliability issue was occurring with the site generator, causing periodic loss of aeration so stopping nitrification.

At the end of January 2021, the power reliability had been improved giving reliable aeration and alkalinity residual greater than 70 mg/l, ammonia removal was capable of reduction of ammonia from incoming 50 mg/l to < 2 mg/l consistently. Several results were at ammonia detection level of 0.01 mg/l.
